# ENGINEERING MAINTENANCE BRANCH BULLETIN

Issue # 009

January 2006

## Vibration Analysis on Sewage Effluent Pumps

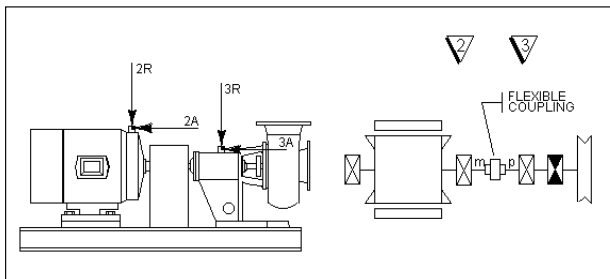
The Sewage Effluent Pump on the T-AO class ships is a single stage centrifugal pump driven by a 5-hp. motor through a flexible coupling. The pump impeller has two vanes, which also act to macerate the solid waste. Here is the diagram and schematic shown in the Vibration Test and Analysis Guide (VTAG).

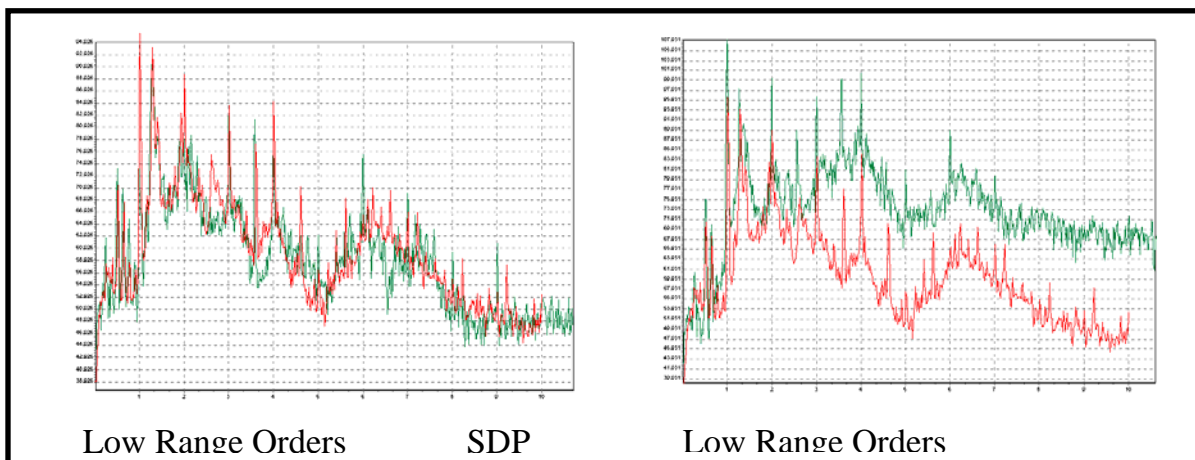
**Figure 1. Axial spectra from Sanitary Pump #1 and Sanitary Pump #2. The green line is the current data and the red line is the average data. Note that the current data on SDP #2 is much higher than the average data.**

The data in Figure 1 clearly shows a much higher noise floor in the spectra on unit #2 than #1. In these plots, we are comparing the data to an average created from 24 fault-free Sanitary Discharge Pumps of the same model in exactly the same application. Pump #1 has spectra that are almost a mirror image of the Average data, while pump #2 has a noise floor that is higher than average and progressively increasing since overhaul in 97. You can think of the noise floor as a measure of the energy present.

**Faults:** EXTREME PUMP INTERNAL WEAR OR  
LOOSENESS (UNSPECIFIED PUMP INFO)  
INDICATED BY:

- 103VdB 4X [2A] Exceedence: 17 VdB.
- 99 VdB 3X [2A] Exceedence: 13 VdB.
- 99 VdB 3X [2R] Exceedence: 10 VdB.
- 99 VdB 3X [2T] Exceedence: 9 VdB.
- 98 VdB 4X [2R] Exceedence: 17 VdB.
- 91 VdB 6X [2R] Exceedence: 24 VdB.
- 89 VdB 6X [2A] Exceedence: 20 VdB.
- 86 VdB 6X [2T] Exceedence: 17 VdB.
- 85 VdB 5X [2A] Exceedence: 27 VdB.
- 84 VdB 4X [2T] Exceedence: 5 VdB.
- 83 VdB 5X [2T] Exceedence: 21 VdB.
- 82 VdB 5X [2R] Exceedence: 15 VdB.
- 81 VdB 11X [2A] Exceedence: 13 VdB.

**MODERATE MOTOR IMBALANCE INDICATED BY:**

- 116 VdB 1X [2R] Exceedence: 21 VdB.
- 112 VdB 1X [2T] Exceedence: 18 VdB.
- 107 VdB 1X [2A] Exceedence: 10 VdB.

**MODERATE BALL BEARING WEAR INDICATED BY:**

- 99 VdB 3.6X [2A] Exceedence: 18 VdB.
- 95 VdB 3.6X [2T] Exceedence: 18 VdB.
- 92 VdB 3.6X [2R] Exceedence: 20 VdB.
- 55 VdB HR floor [2A] Exceedence: 7 VdB.
- 55 VdB HR floor [2R] Exceedence: 8 VdB.

**MANDATORY:** INVESTIGATE PUMP/FAN  
ELEMENT COUNT AND COMPARE TO  
DATA

**DESIRABLE:** BALANCE UNIT.

**DESIRABLE:** REPLACE BEARINGS
